Re: September 2016 Monthly Progress Report
Administrative Settlement Agreement and Order on Consent for Removal Action
U.S. EPA Region 10 Docket No. CERCLA 10-2009-0255
Gasco Sediments Site within the Portland Harbor Superfund Site

Attachment A Monthly Visual Monitoring Report for Pilot Cap Vicinity

Visual Observations Log Form

Monitoring Period: Monthly (Year 10)— September 2016

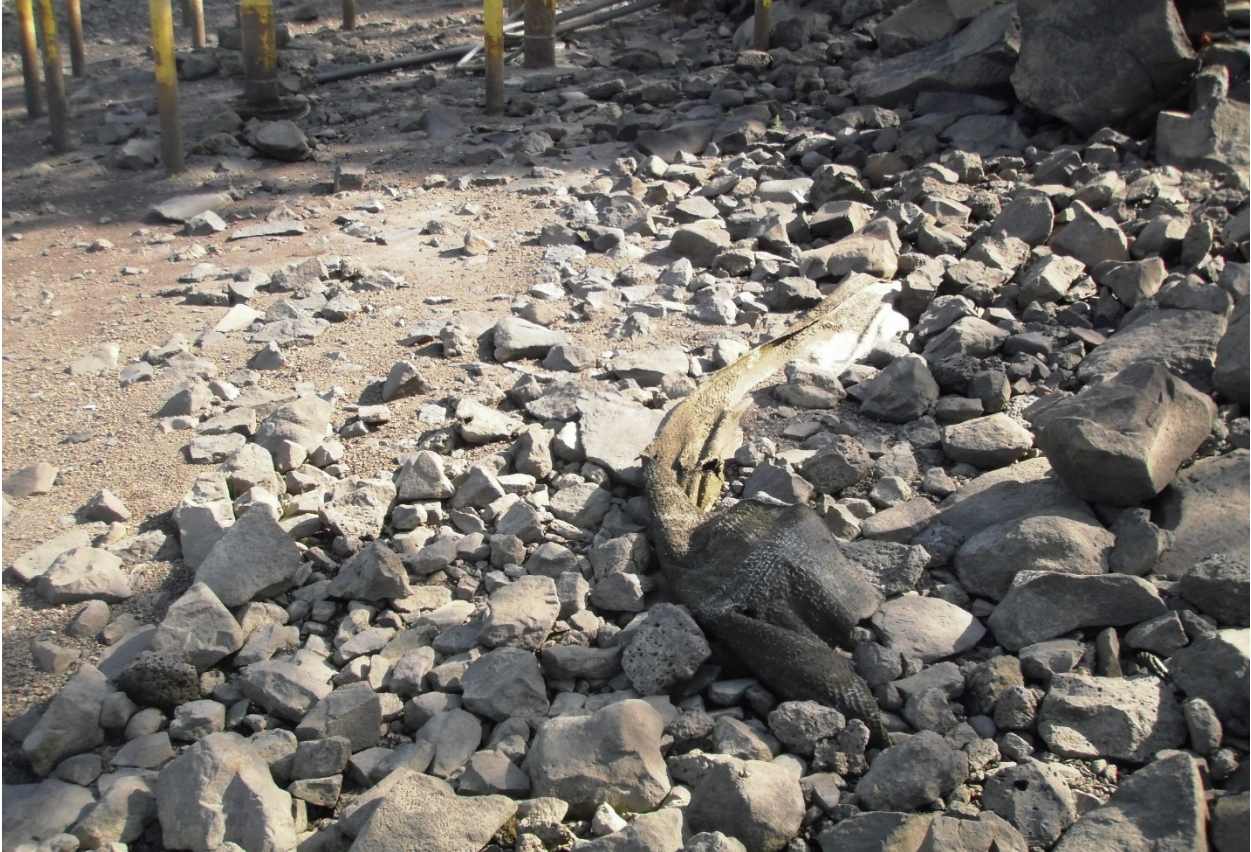
Observations of Erosion/Deposition: No erosion/deposition was evident along the shoreline. All previously noted organo-clay mat material segments are visible. A segment 5 feet in length is out of the water approximately 6 feet from the water's edge, near the lateral mid-point of the cap area (Photo 1). A 15-foot section is shoreward of the water's edge, perpendicular to the shoreline at the upriver boundary of the cap area. A section of organo-clay mat material measuring 40 feet in length is exposed near the downriver extent of the cap at the water's edge.

Photo 1 — *Mat material visible at the lateral mid-point of the cap area. (9/22/16):*

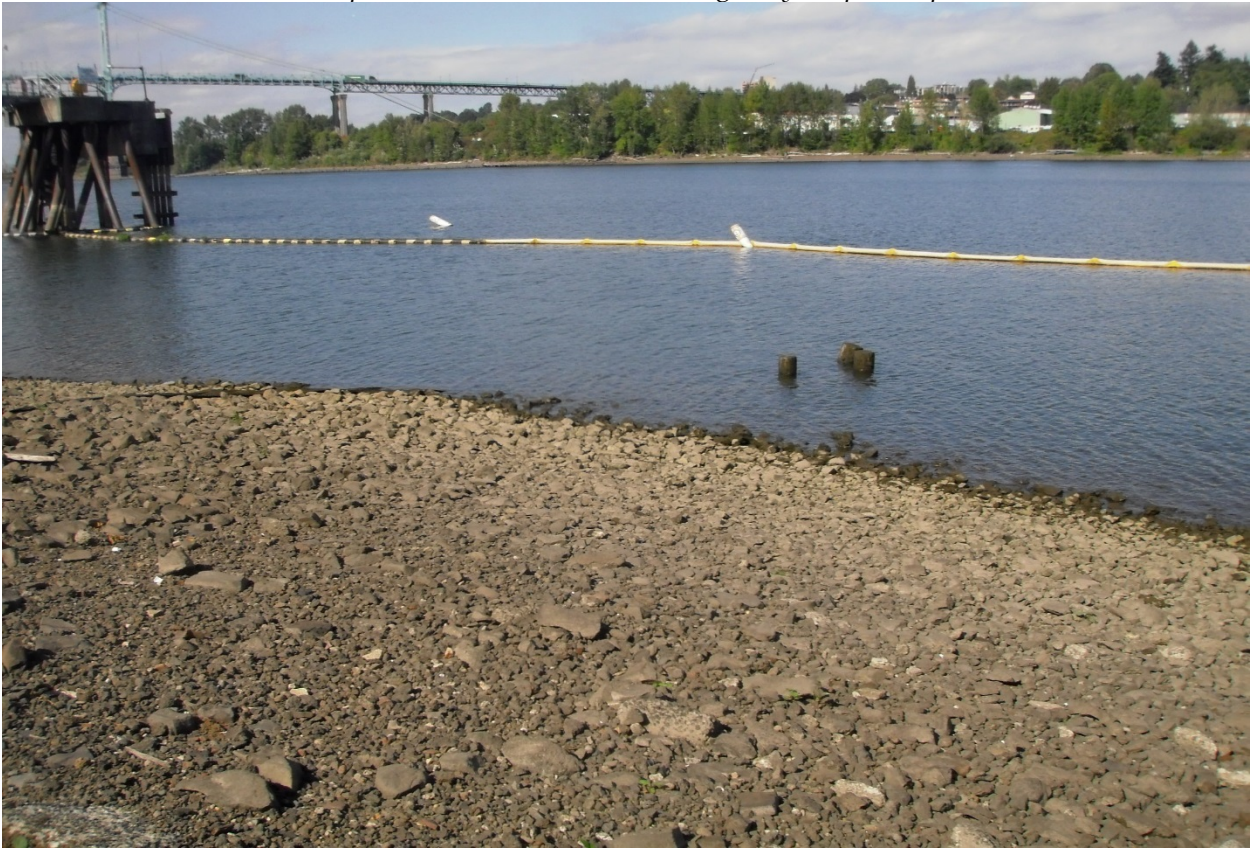
Observations of Long-term Controls (i.e., oil booms, organo-clay mat, etc.) During the observation, the FAMM containment boom was in place across the cap area from the ship dock to an anchor point riverward of the upriver dolphin. Two buoys that identify the cap area to mariners were in place as installed. One of the buoys was shoreward of the boom while the other was riverward of the boom. The position of the FAMM oil boom and warning buoys is shown in Photo 2.

Photo 2 — *FAMM oil boom placement and mariner warning buoys at pilot cap area. (9/22/16):*

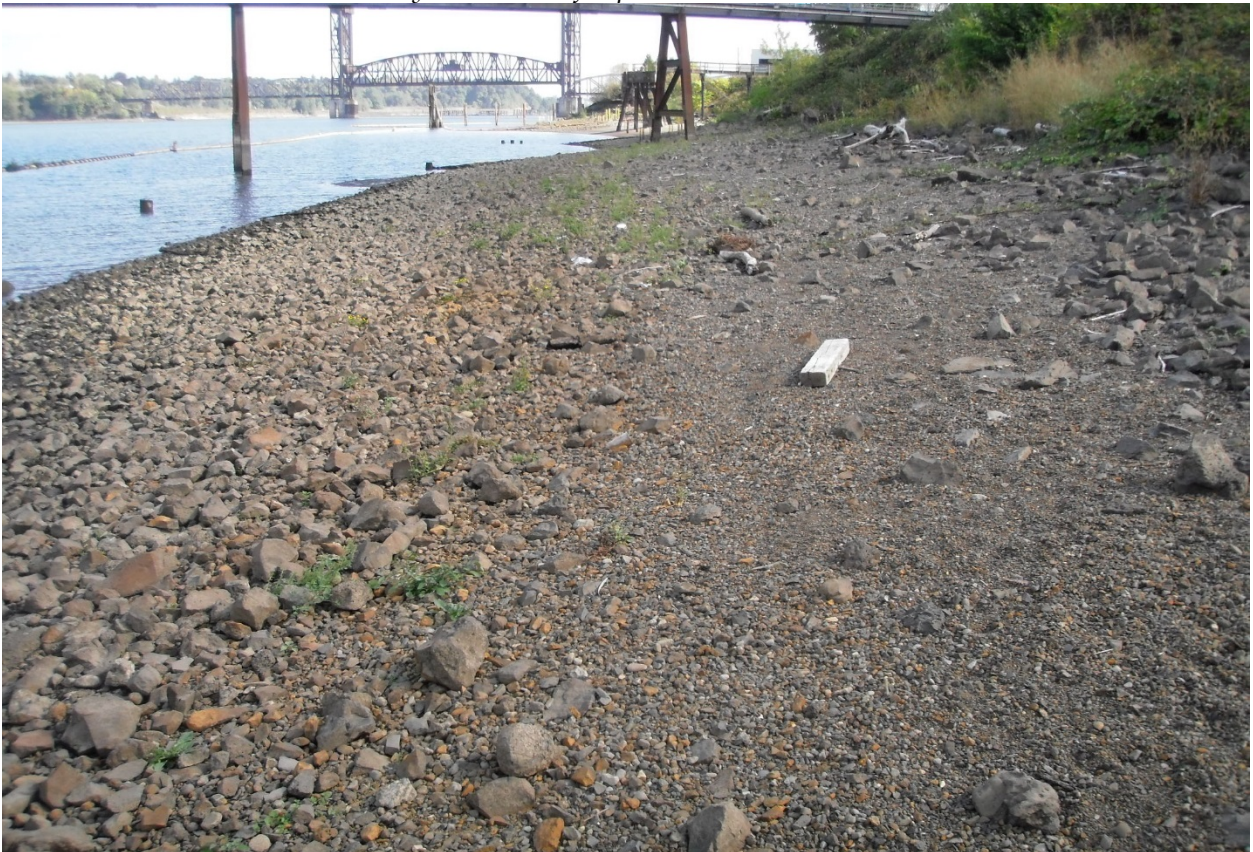
No sheen was evident in or around the cap area. Photo 3 shows the water surface and shoreline immediately downriver of the sediment cap.

Photo 3 — *Conditions immediately downriver of cap area 9/22/16):*
